# Manhole Inspection Summary

Manhole # S250\_\_016MH

Insp Date: **4/2/08 10:28 AM**

**Location** Address: **1307 S. Washington**

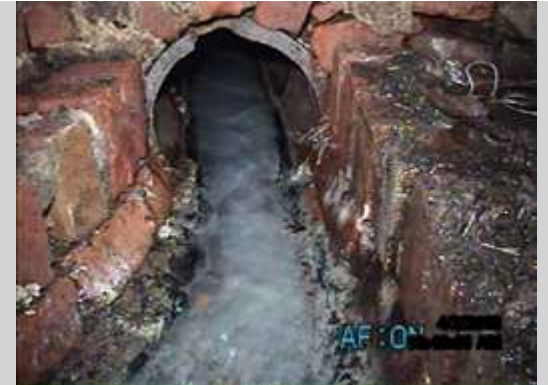
12 O'Clock Outflow

8 in. Circular Gravity Sewer  
Pipe Out @ 12 O'Clock

Pipe Height: **8.4** (in.) Rod and Bar (Angled)  
Pipe Material: **Clay** ☐ Pipe Lined  
Invert Depth: **10.21** (ft.) Flow Characteristics: **Slow**  
Deposits: ☒ None ☐ Mud ☐ ~~Gravy~~ ☐ Debris ☐ Grease  
Silt Depth: **0** (in.) Deposits Extent:  
Infiltration: **None** Pipe Seal Cond: **Sound**
